COWICHAN VALLEY NOVEMBER 2009  
FLOODING – DOCUMENTATION AND  
ASSESSMENT

FINAL REPORT

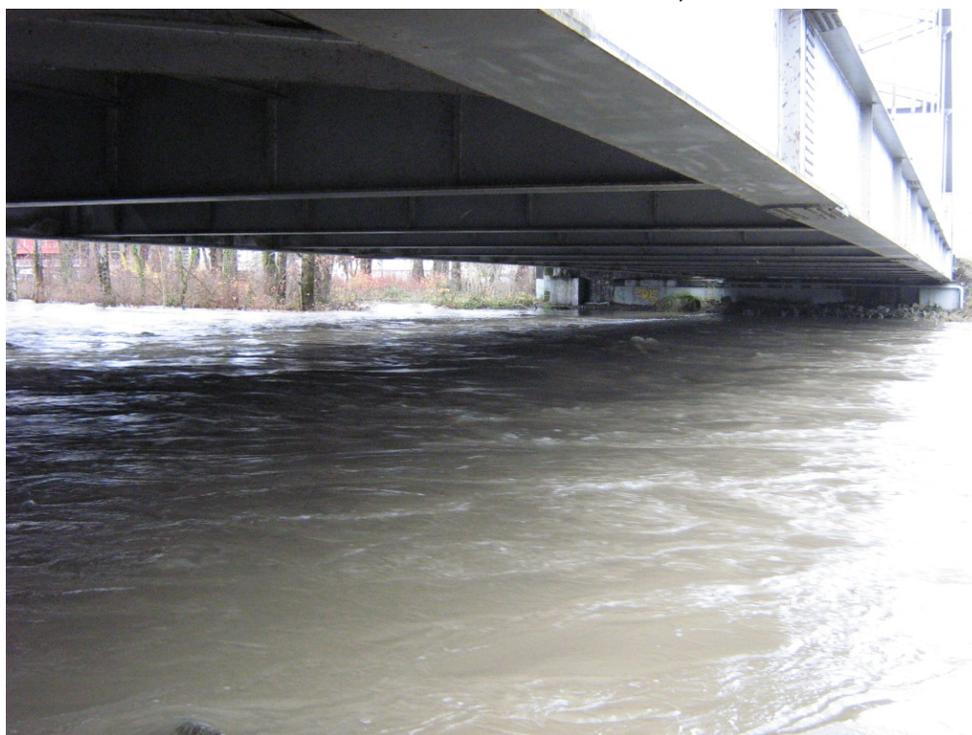
Photo 6-1: Cowichan River at Highway #1 bridge near peak flow on November 20<sup>th</sup>, 2009.

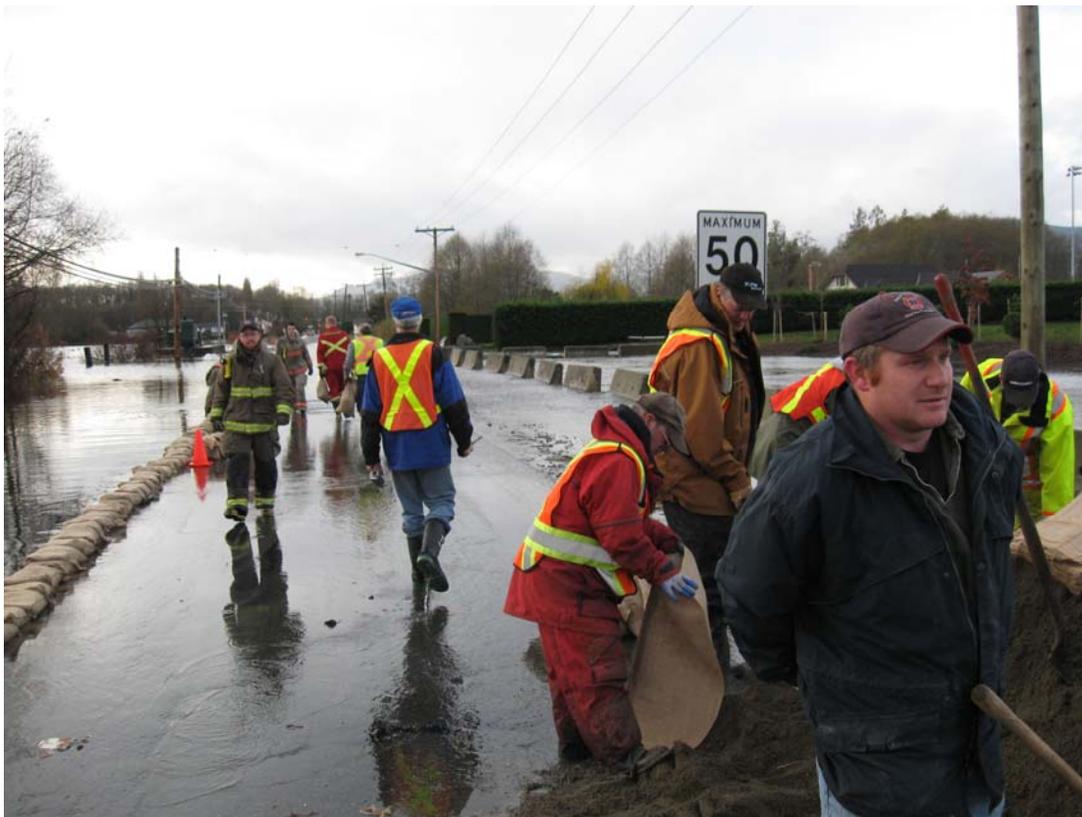
The MNC installed an emergency flood wall along Lakes Road using concrete “no-post” barriers (Photo 6-2). The top elevation of the barriers varies between 8.2 and 8.4 m (described as “> 8.1 m” on survey plan *2009 Flood Plan.pdf*). The top of the barriers coincides closely to the estimated 25 year flood level (without freeboard) along Somenos Creek. We understand the emergency barrier is not intended as a permanent solution to the flooding problem but is intended to reduce the threat of a repetition of the November 2009 flood during the remaining flood season (peak flows have typically occurred between December and March). The barrier will mainly reduce the extent of flooding from water entering via Somenos Creek. It will not prevent inundation from flood water that enters through the mainstem of the Cowichan River (via JUB lagoon dikes or the present opening between the JUB Lagoons and the Cowichan Dike) or from internal flooding due to excess precipitation behind the dikes. Furthermore, in the event of a very extreme flood it may be necessary to open portions of the barrier to allow drainage out of the inundated areas, or to provide pump water over the barrier.

Photo 6-2: Construction of temporary no-post barrier on Lakes Road.

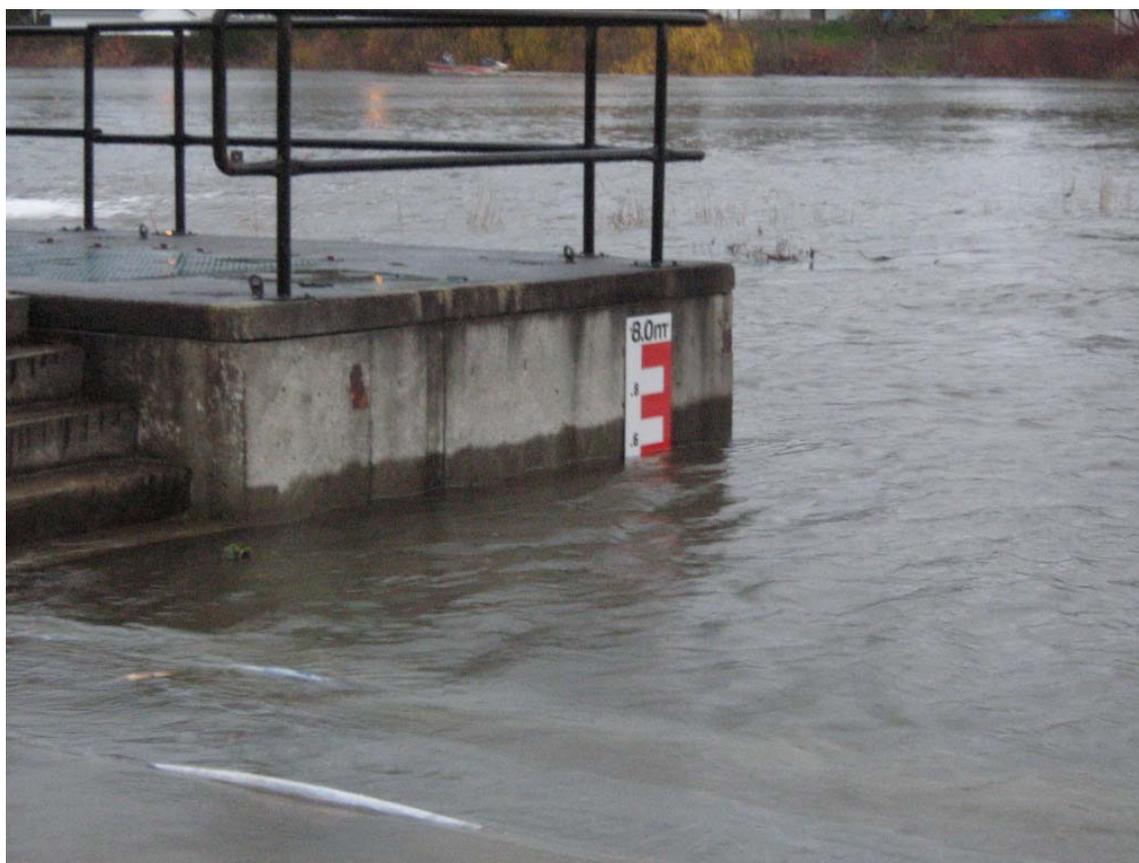
Photo 6-3 shows the pump station near Beverly Street on November 20<sup>th</sup>. The maximum water level in this location reached about 7.7 m. By comparison, NHC (2009) estimated the 200-year flood level (without freeboard) is approximately 8.8 m (just below the top of the railing).

Photo 6-3: Pump station near Beverly Street November 20, 2009

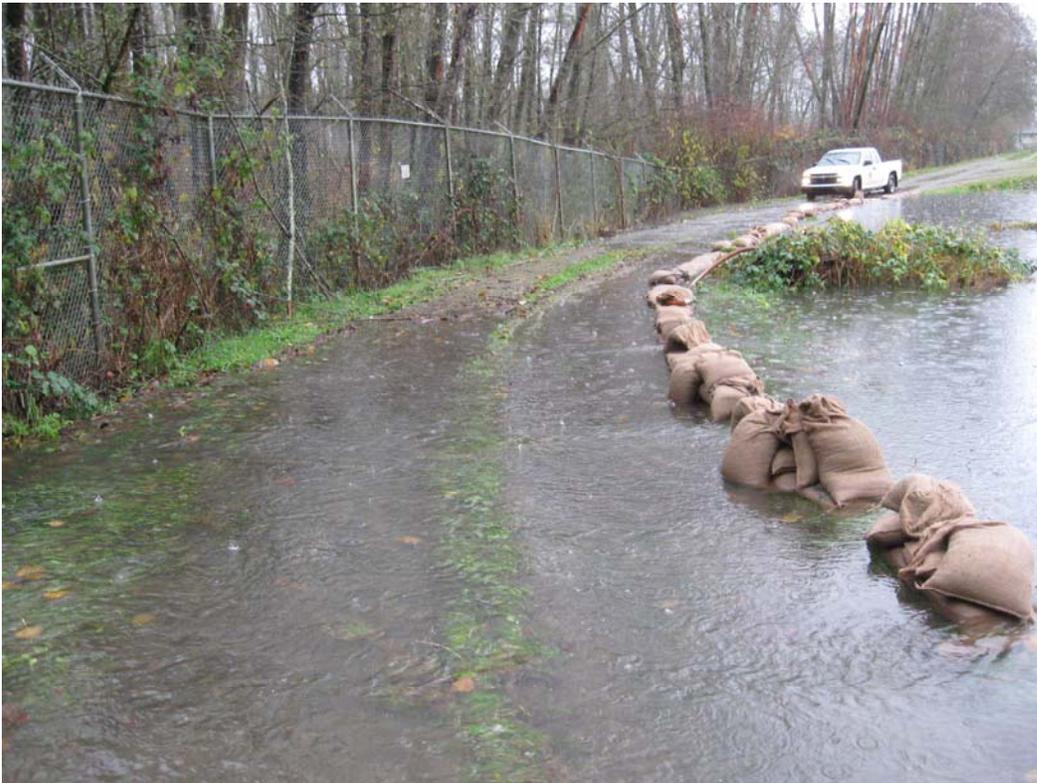
An inadequate dike currently separates the JUB lagoons from the Cowichan and Somenos Rivers. This is documented in the September 2009 IFMP reporting. The inadequacy of this dike was clearly shown on November 20<sup>th</sup>, when water was observed passing over the dike (Photo 6-4). Fully treated effluent from the lagoons flowed into the river (documented in video footage), and some river water is assumed to have passed into the lagoons. The failure of this diking system has serious implications to public and environmental health well-beyond simple structural damage resulting from floodwaters.

Photo 6-4: Overtopping of JUB Lagoon dike on November 20<sup>th</sup>, 2009.

Proposed upgrades to the JUB Sewage Lagoon dike will increase freeboard around the overall 1.1 km perimeter giving rise to an estimated 5 m horizontal displacement beyond the existing structure. As an added measure of flood protection 670 m x 5 m of rock armouring is proposed along the toe of the upgraded dike given the serious implication of failure for this dike. An estimated 6,700 m<sup>2</sup> of sensitive aquatic and riparian habitat associated with lower Fish Gut Alley channel may be altered depending on the design.

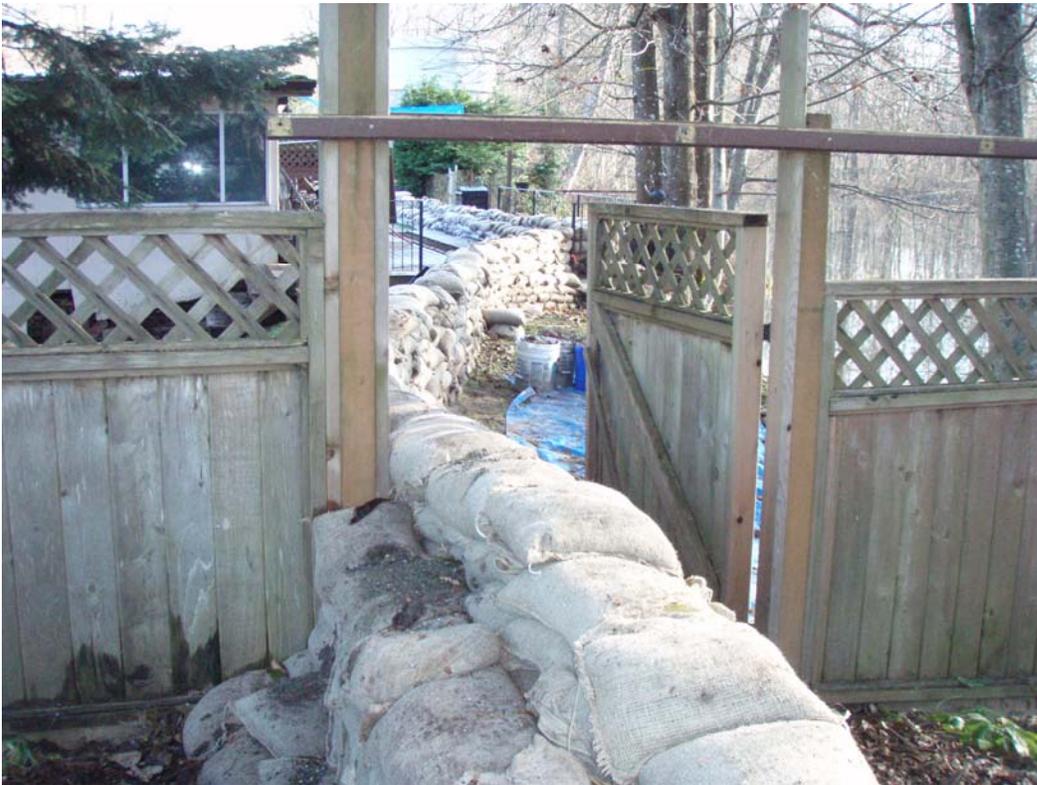
Flooding of properties along Lee Street was a result of conditions along Fish-gut alley/Rotary channel. This watercourse is a side channel of the Cowichan River that is bounded on the north and south by two sports fields and discharges south of the hatchery. Two culverts pass through Cowichan River dike near chainage 300 and 400 allowing water to drain from Rotary Park and flow into the Cowichan River.

Photo 6-5: Lee St Sandbag Dike running through backyards.

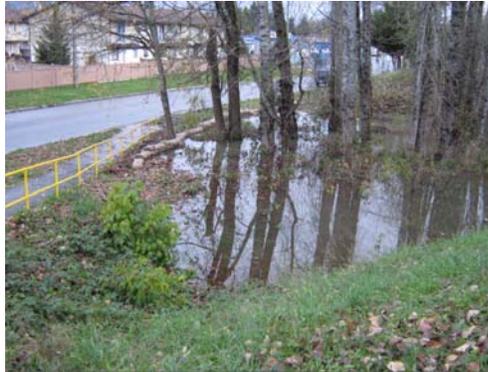
2. During the flood, water ponded in the area bounded by Lakes Road, the JUB Lagoon Dike and the Cowichan River Dike (see Photo 3-1). The Cowichan Dike does not connect to the JUB dikes, possibly allowing water to flow between the dikes. After the flood had receded, possible signs of seepage were observed near the toe of the Cowichan Dike near chainage 30.

Furthermore, a storm sewer drains water from the City of Duncan Public Works Yard and flows into the Cowichan River after passing under the Cowichan River dike near chainage 30. The culvert outflow does not have a control gate and signs that the pipe is cracked were noticeable near the Public Works Yard where water was seen bubbling up through cracks in the pavement. Similar leaks in the pipe are possible under the flooded area closer to the dike. The source of the water observed in Photo 3-1, is likely from one or a combination of the sources listed above.

Photo 3-1: Flooding on land side of Cowichan Dike near chainage 10.

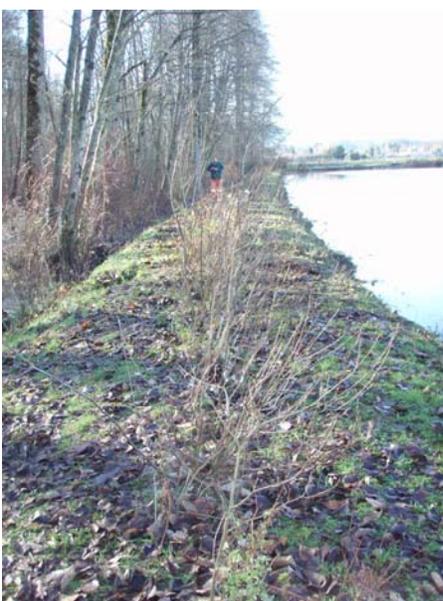
1. Portion of the dike on the south of the middle cell (cell #5) is lower than the rest of the lagoon dike. It is suspected that the dike was overtopped during the flood along that lower portion but it is known that the water level in the lagoon was higher than the dike crest elevation. Effluent from the lagoon flowed over the dike and into the river.
2. Vegetation (including large trees) is present in and near the dike on the river side (see Photo 3-2).

Photo 3-2: Trees growing along crest of dike and near the toe on the river side.

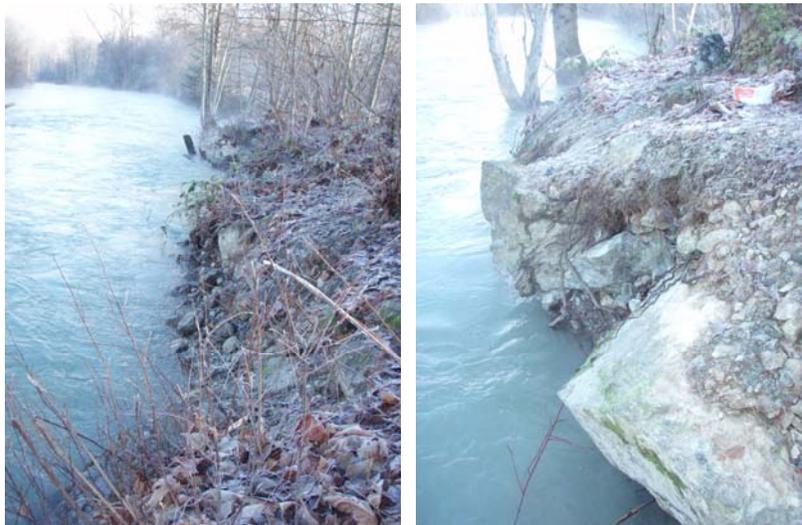
1. Overgrown vegetation (including large trees) is present in and near the dike on the river side and land side.
2. No riprap protection along the majority of the dike. Note that fast flowing water was observed on the river side of the dike.
3. Significant erosion was observed along a 200 m-long section of the dike. Also, there was erosion due to fast currents along the toe and side of dike (see Photos 3-3 and 3-4).

Photos 3-3 and 3-4: Erosion due to fast currents between chainages 500 and 600.

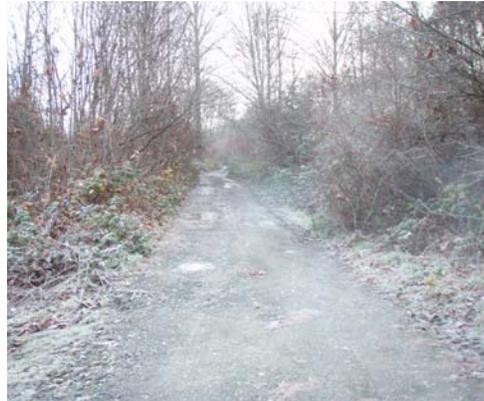
1. Overgrown vegetation (including large trees) is present in and near the dike on the river side and land side (Photo 3-5).

Photo 3-5: Vegetation and large trees growing on both sides of Quamichan Dike.

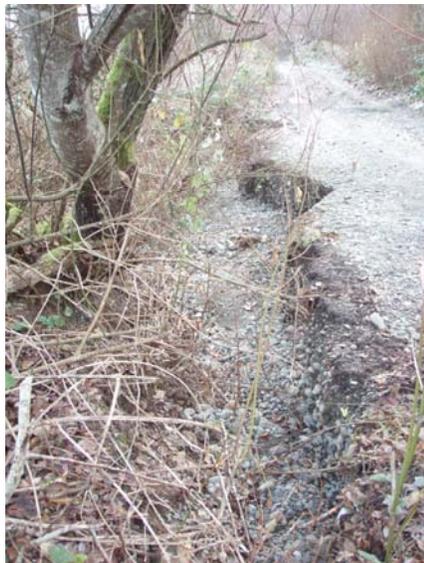
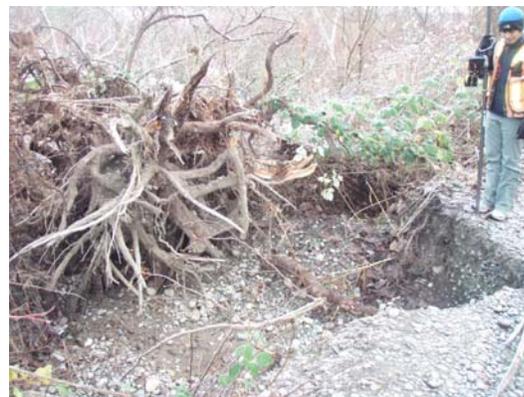
2. No riprap protection along the majority of the dike. Note that fast flowing water was observed on the river side of the dike.
3. Uprooted tree and significant erosion of the dike was observed on the land side of the dike near chainage 1000. A small (now dry) channel with evidence of fast flows caused the erosion which led to the uprooting of the tree (Photos 3-6 and 3-7).

Photo 3-6: Eroded side of Quamichan Dike (land side); Photo 3-7: Large uprooted tree and erosion of the Quamichan Dike (land side) near chainage 1000.

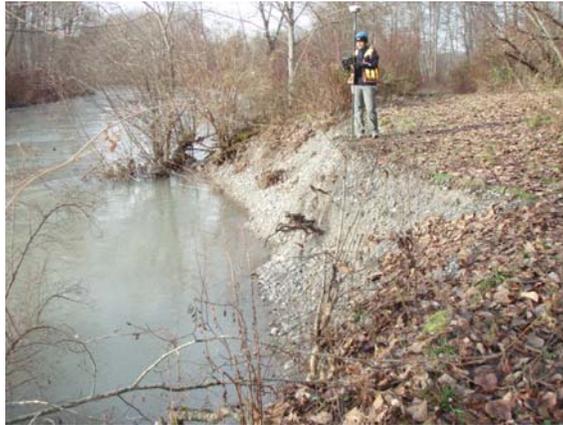
4. Significant erosion along dike near chainage 100 (Photo3-8).

Photo 3-8: Gradual erosion of the Quamichan Dike (river side) near dike chainage 100.

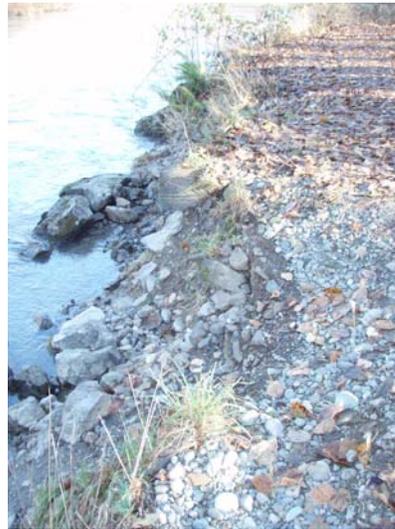
1. Significant erosion and loss of riprap protection was observed at dike chainage 400 (see Photo 3-9).

Photo 3-9: Significant erosion and loss of riprap protection

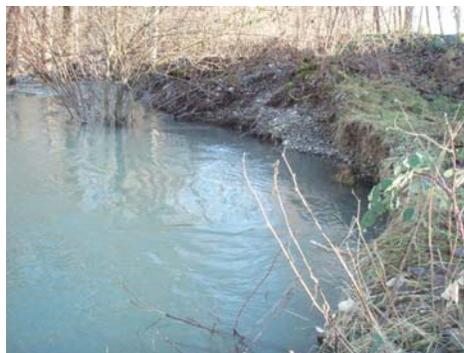
2. Erosion along Mission Road Dike near chainage 200 (Photo 3-10).

Photo 3-10: Erosion along Mission Road Dike.

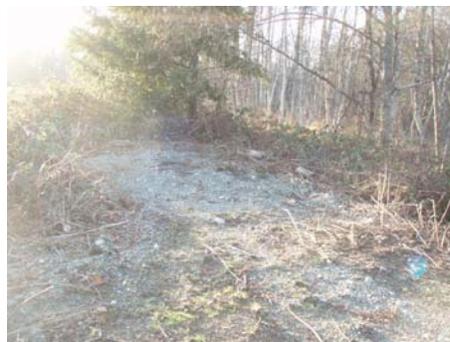
3. Overgrown vegetation (including large trees) is present in and near the dike on the river side and land side of both Hatchery and Mission Road Dike(Photo 3-11).

Photo 3-11: Overgrown vegetation on Mission Road Dike.

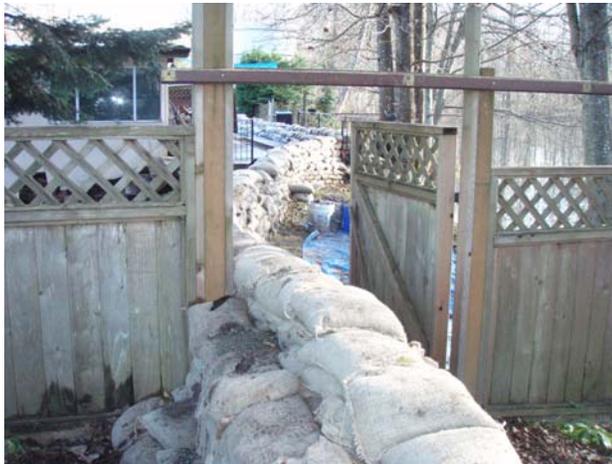
High water levels on the river side and overgrown vegetation obstructed the complete assessment of deterioration or damage on the lower side slope and toe of the dike. Fast flowing water was observed along the unprotected river side of the dike. The non-standard dike was raised with sandbags as part of emergency protection installed in November 2009 (Photo 3-12).

1. Dike was overtopped during recent flood event (prior to sandbagging).
2. Trees, fences, and decks are in or near the dike.

Photo 3-12: Dike raised with sandbags.
