**COWICHAN ESTUARY ENVIRONMENTAL MANAGEMENT PLAN
COMMITTEE MEETING**

Cowichan Bay Intertidal and Subtidal Habitat Assessment and Environmental Impact Statement - WFP Log Storage Tenures (March 2014)

Intertidal and Subtidal Habitat Assessment and Environmental Impact Statement Western Forest Products Ltd. Log Storage Tenures

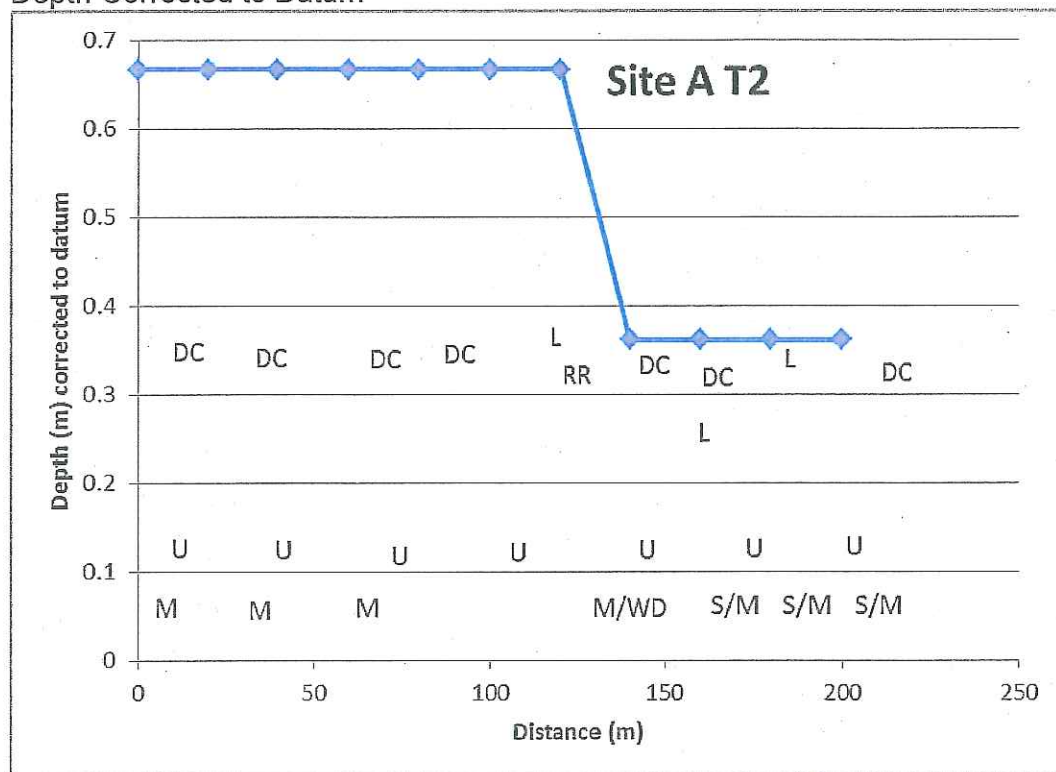
Figure 6: Spatial Distribution of Site A – Transect 2 Observations, Distance and Depth Corrected to Datum

The substrate is comprised primarily of fine sand or mud. Ulva is the primary seaweed. Dungeness crab, and red rock crabs comprised some of the macro fauna observed. Spatial distribution of observations within this transect is provided in Figure 6.

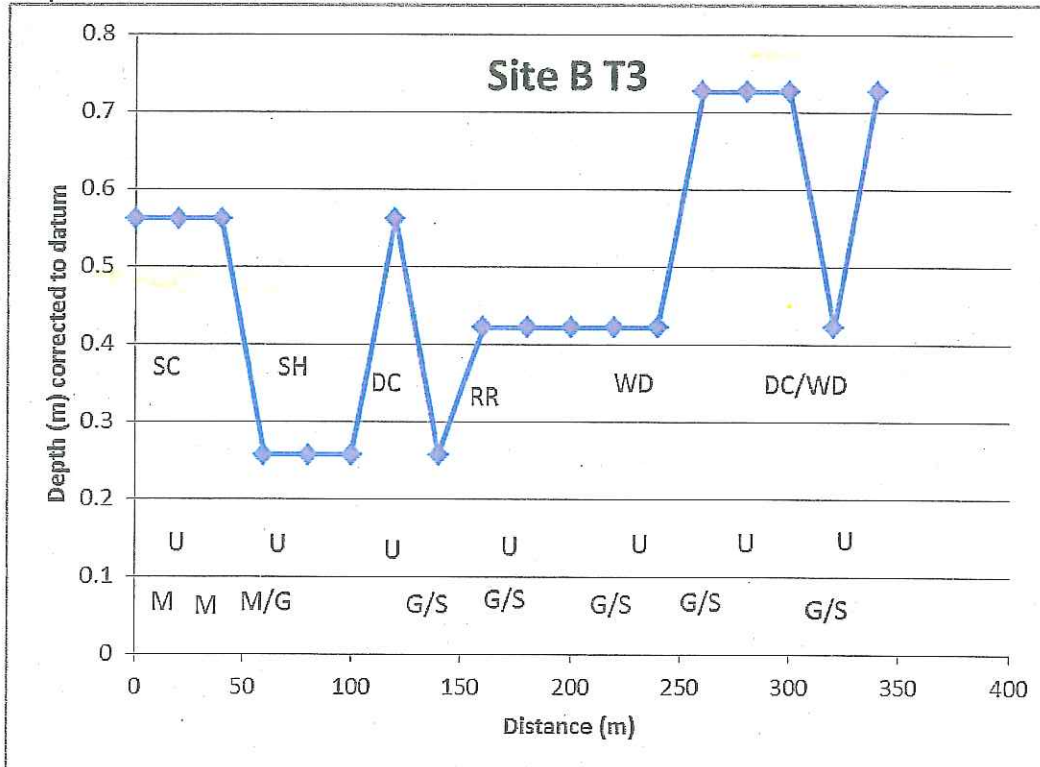
Figure 7: Spatial Distribution of Site B – Transect 3 Observations, Distance and Depth Corrected to Datum

The substrate is comprised primarily of gravel and cobble with some sand and mud. The dominant seaweed is *Ulva*. Dungeness crab and red rock crabs were observed. Spatial distribution of observations within this transect is provided in Figure 7.

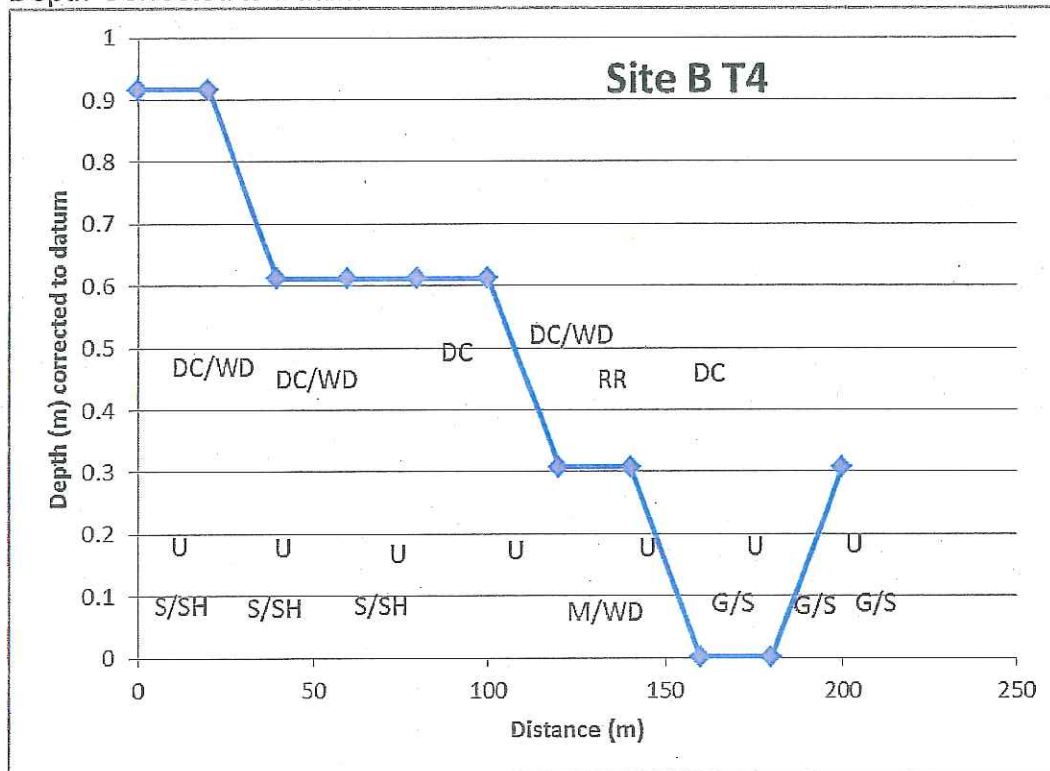
Figure 8: Spatial Distribution of Site B – Transect 4 Observations, Distance and Depth Corrected to Datum

and red rock crab were observed during the dive. Spatial distribution of observations within this transect is provided in **Figure 8**.

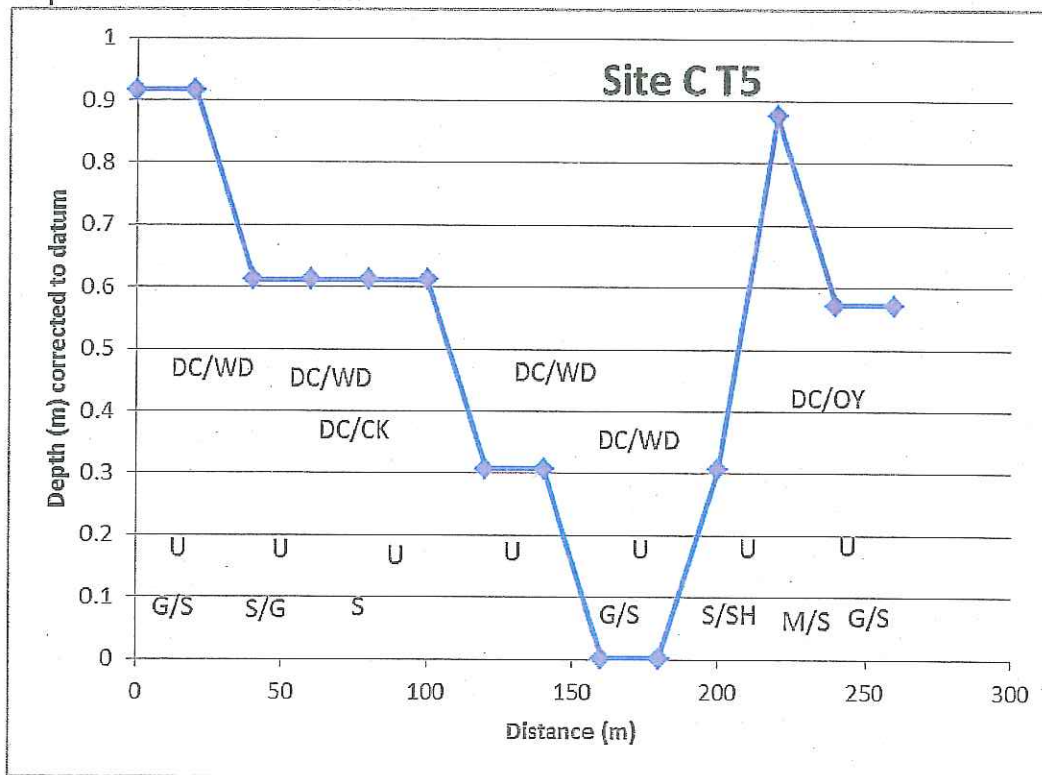
Figure 9: Spatial Distribution of Site C – Transect 5 Observations, Distance and Depth Corrected to Datum

The primary substrate is gravel and sand. The dominant seaweed is Ulva. Oysters, cockles and Dungeness crab were observed. Woody debris was present along transect. Spatial distribution of observations within this transect is provided in **Figure 9**.

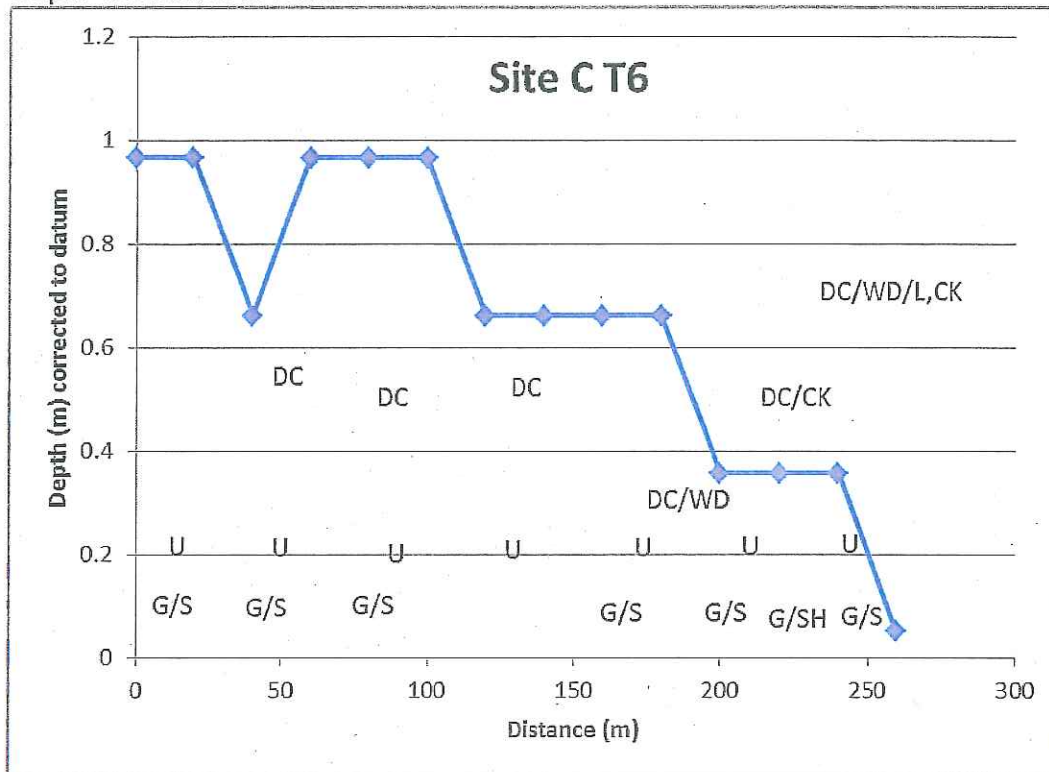
Figure 10: Spatial Distribution of Site C – Transect 6 Observations, Distance and Depth Corrected to Datum

The primary substrate is gravel and sand with Ulva covering it. Cockles and Dungeness crab were observed. Woody debris was present along transect. Spatial distribution of observations within this transect is provided in **Figure 10**.

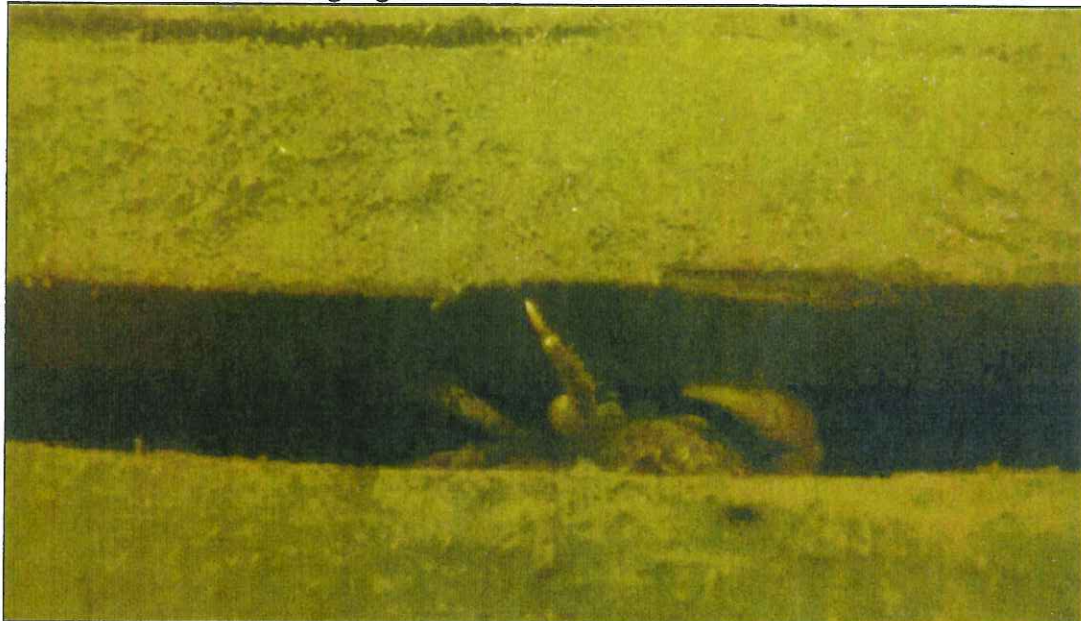
Transect 1: Crab utilizing log for cover

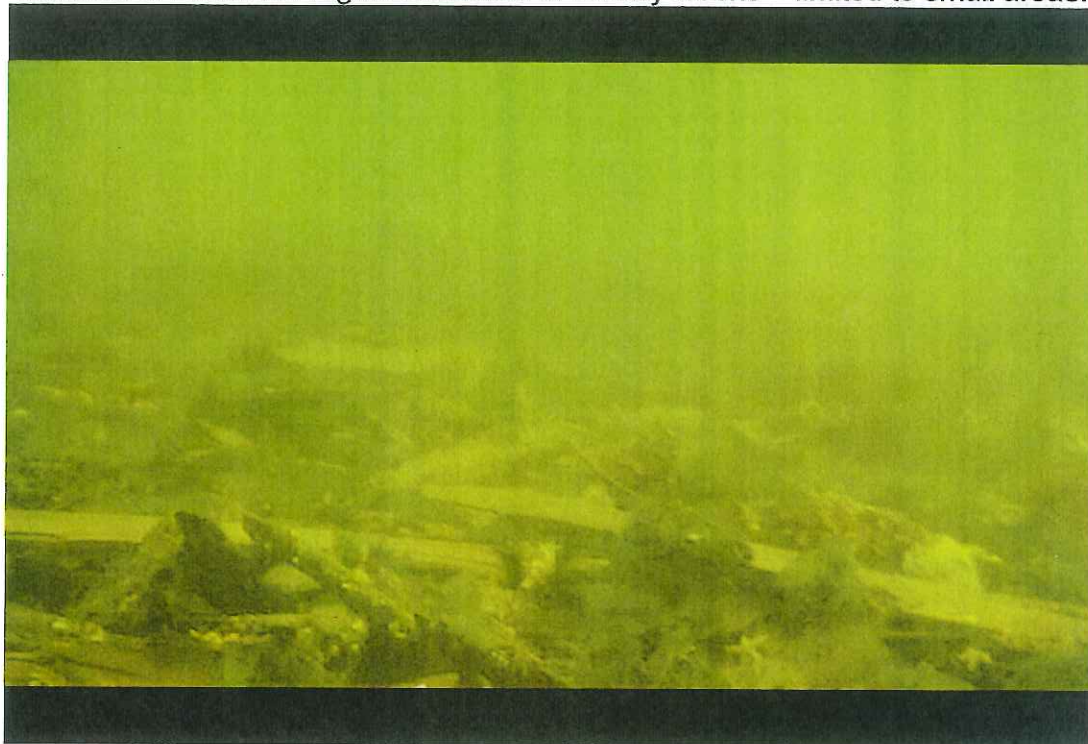
Presence of woody debris generally low. Isolated pockets of woody debris spanning approximately 10-15 m in linear length along the transect between 50-60 m and 150 m along the length of the transect. Underlying substrate was observed amongst the woody debris, suggesting that the depth of the woody debris was low. This area was utilized by Dungeness crabs, red rock crabs, barnacles and sea stars. No anaerobic bacterial mats or evidence of anoxic conditions were observed. Of the logs observed, they appear to have been present for a significant amount of time, with evidence of utilization by a variety of wood-boring invertebrates (refer to photographs for details).

Transect 2: Localized Higher Densities of Woody Debris – limited to small areas.

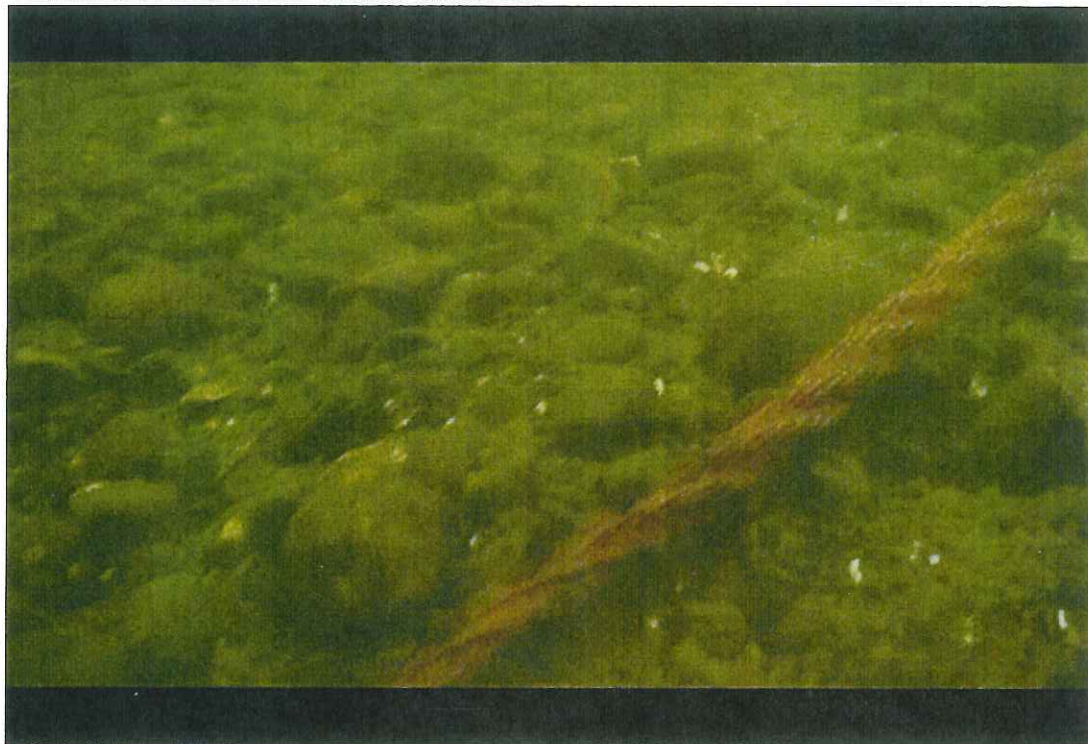
Transect T3 - Portion of a rusty chain (located at distance of 340 m along transect)

Transect 3: Cable and Gravel Substrate

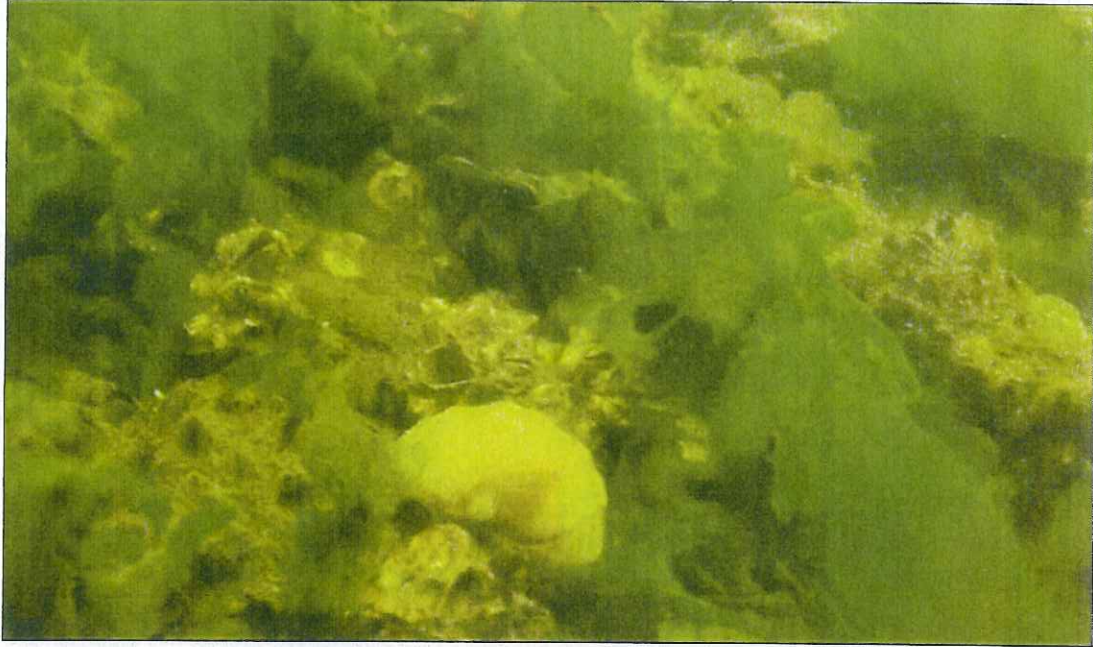
Transect 4: Barnacles and Hermit Crab Utilizing Woody Debris

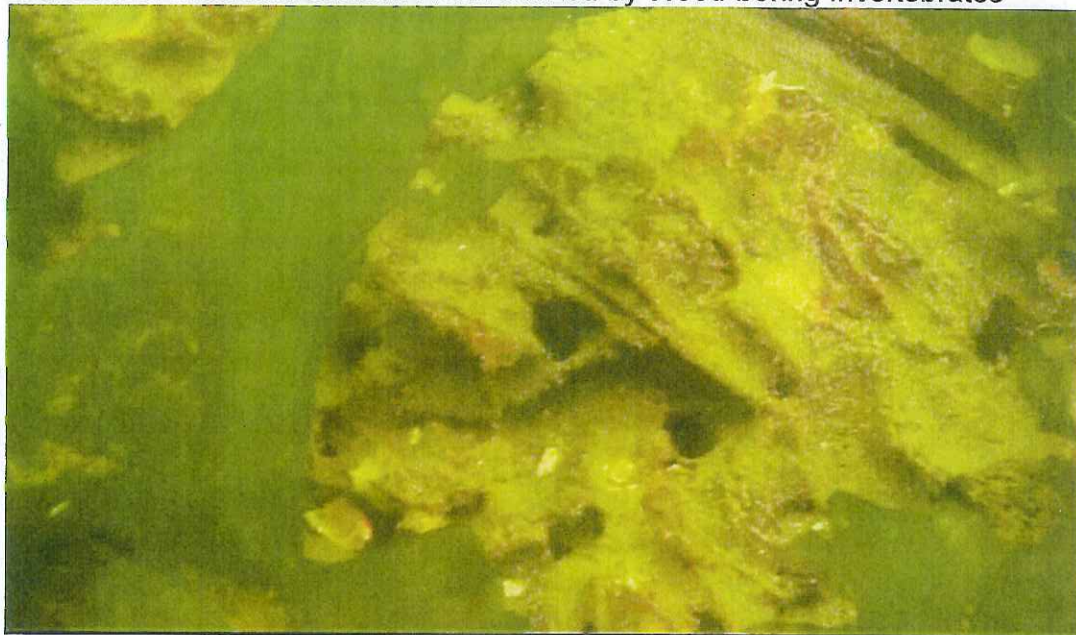
Two logs were observed and both were in advanced states of decay, being utilized by hermit crabs, ulva and wood-boring invertebrates. Isolated, scattered areas containing fine woody debris was observed at 30 m, 60 m, 150 m and 160 m along the length of transect, typically in patches of less than 10 m in length. Underlying substrate was observed amongst the woody debris, suggesting that the depth of the woody debris was low. No anaerobic bacterial mats or evidence of anoxic conditions were observed.

Transect 5: Localized Sunken Wood Utilized by Wood-boring Invertebrates

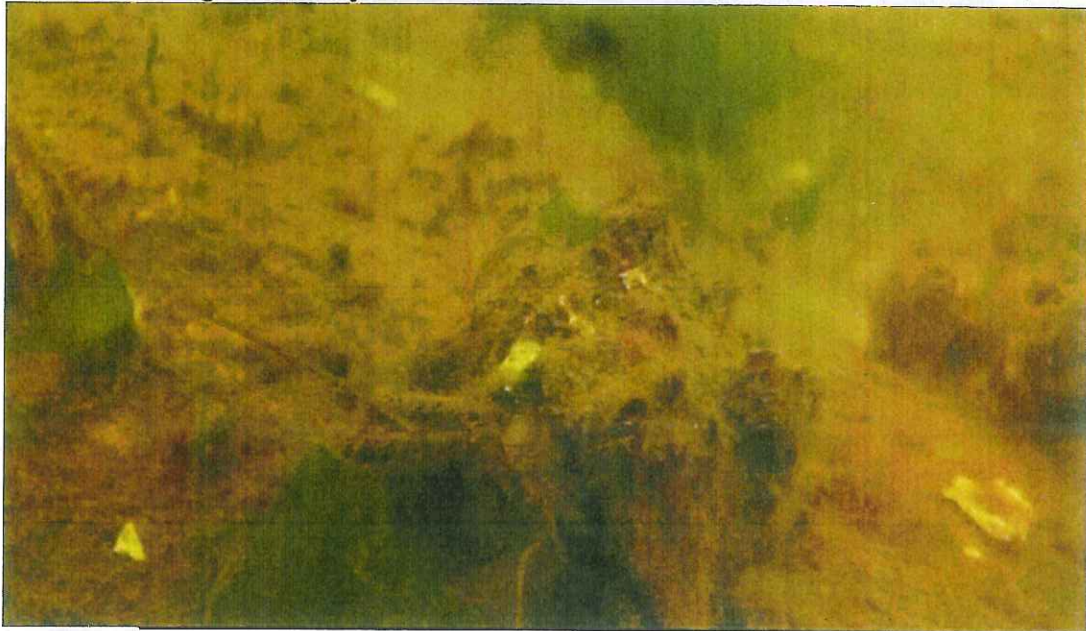
Transect 7: Log Utilized by Hermit Crabs
