COWICHAN VALLEY NOVEMBER 2009  
FLOODING – DOCUMENTATION AND  
ASSESSMENT

FINAL REPORT

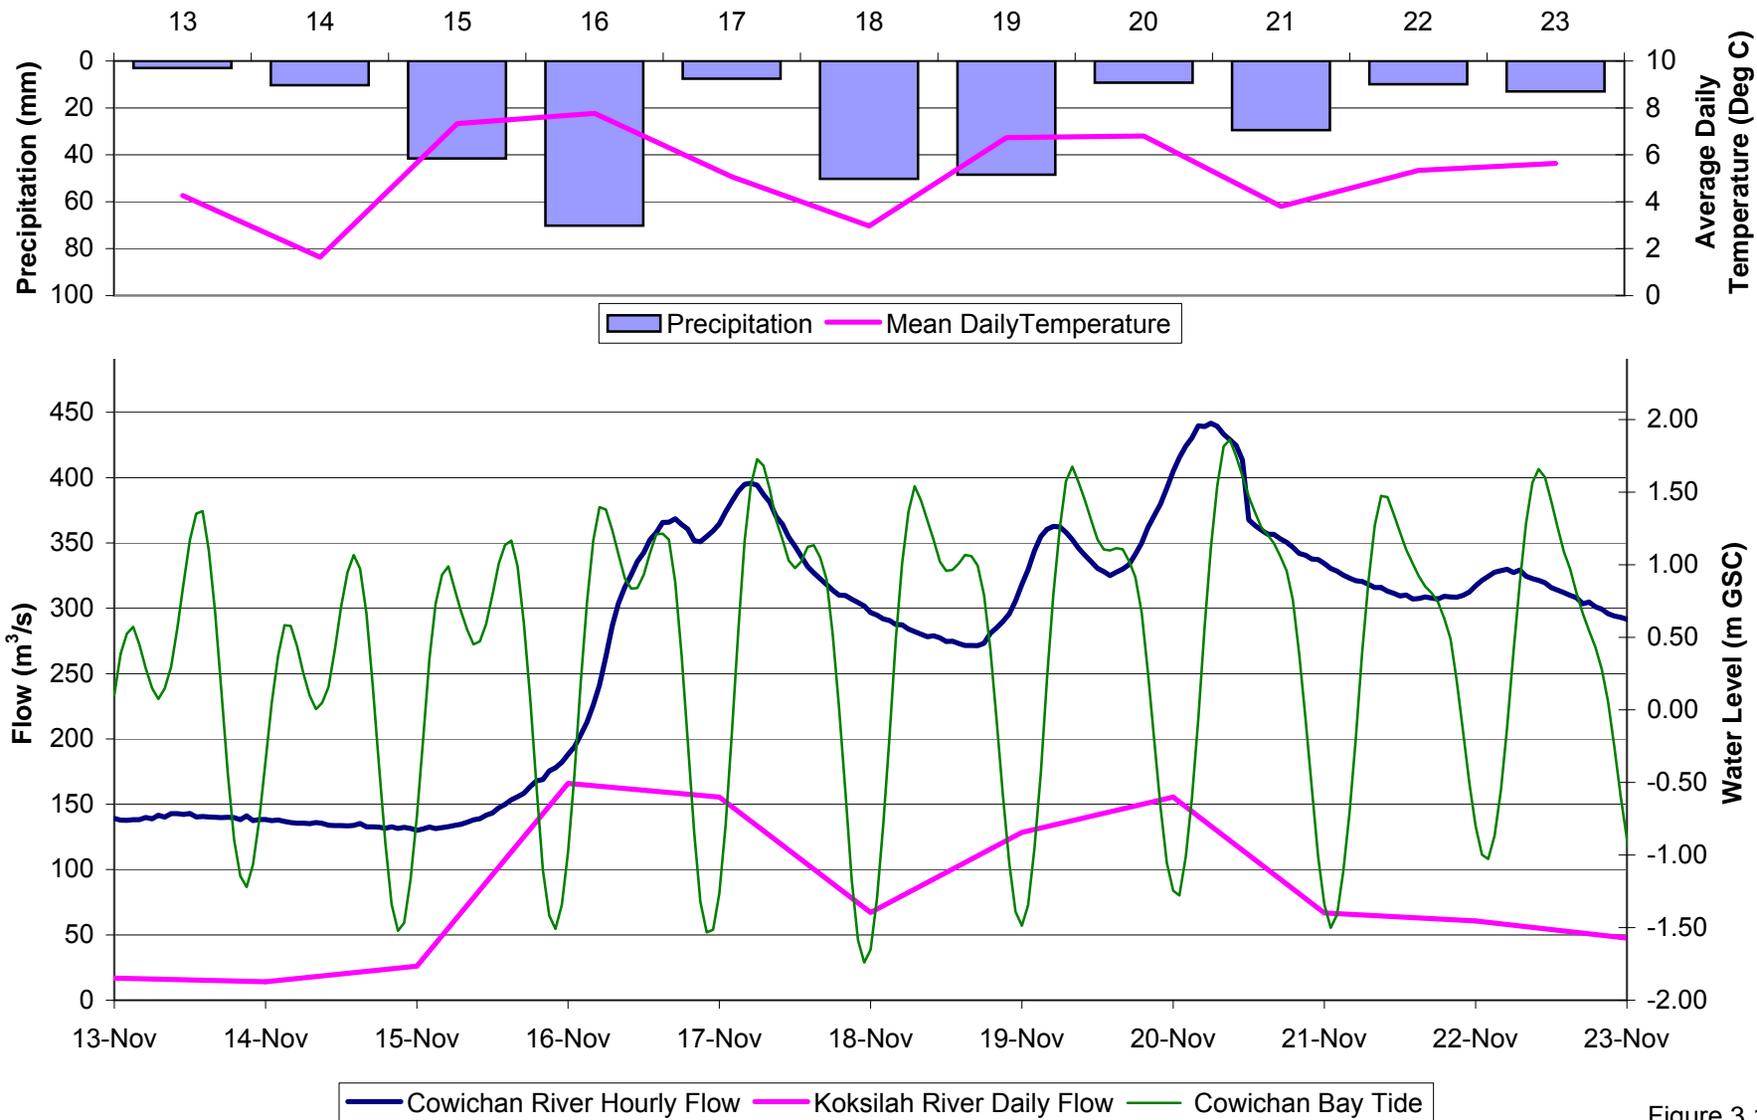
Figure 3.1

There is no tide gauge in Cowichan Bay to measure actual water levels. However, the Canadian Hydrographic Service provided NHC with adjusted tide levels for Cowichan Bay<sup>1</sup>. The adjusted tide levels are based on the predicted tide levels and include a storm surge adjustment based on measured storm surges at nearby stations. Tide levels from CHS are presented in Figure 3.1. The recorded high tide at Cowichan Bay on November 20 was 1.9 m GSC at 09:00 PST.

Inflows for the Cowichan River were based on hourly discharges from WSC's Cowichan River near Duncan (08HA011) gauge. Inflows for the Koksilah River were daily flows from WSC's Koksilah River at Cowichan Station (08HA003) gauge. Inflow hydrographs are plotted in Figure 3.1.

Levels in Cowichan Bay at the mouth of the South and North branches of the Cowichan River were based on pseudo water levels time series provided by CHS for Cowichan Bay (Station #7310). The pseudo-observed tide levels (Figure 3.1) include a storm surge adjustment based on measured values at nearby stations.

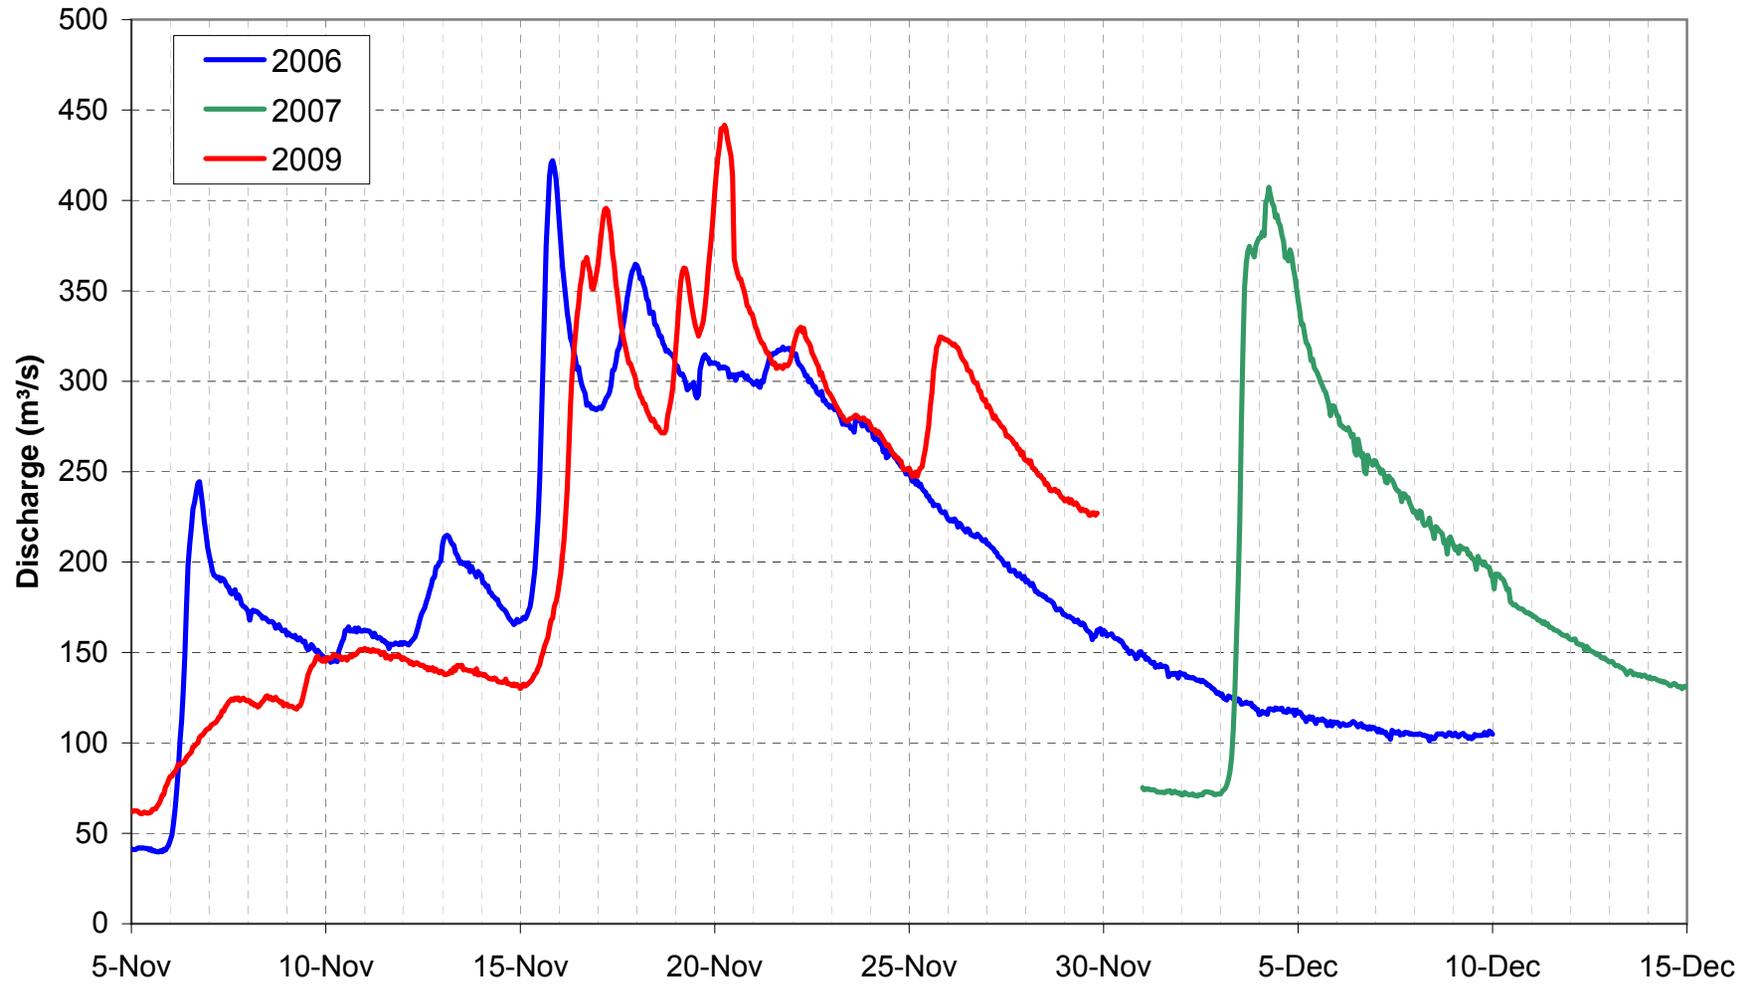
Figure 3.2 compares hydrographs from floods in November 2009, December 2007 and November 2006. The 2009 flood was higher in magnitude and had a longer duration than either of these recent events. Table 3.1 summarizes other historic floods on the Cowichan and compares the 5-day precipitation totals (at Duncan) and peak discharges. The total rainfall volume in 2009 was considerably higher than in previous years. The 2009 instantaneous maximum discharge was the highest since 1986 (virtually identical) and only the record flood of 1961 was significantly higher in magnitude (558 m<sup>3</sup>/s). However, a flood frequency analysis indicated the 2009 flood event was not particularly severe, having a return period of approximately 7 years (based on instantaneous maximum discharges). By comparison, the 25-year and 200-year instantaneous flood discharges are 572 m<sup>3</sup>/s and 703 m<sup>3</sup>/s respectively (NHC, 2009).

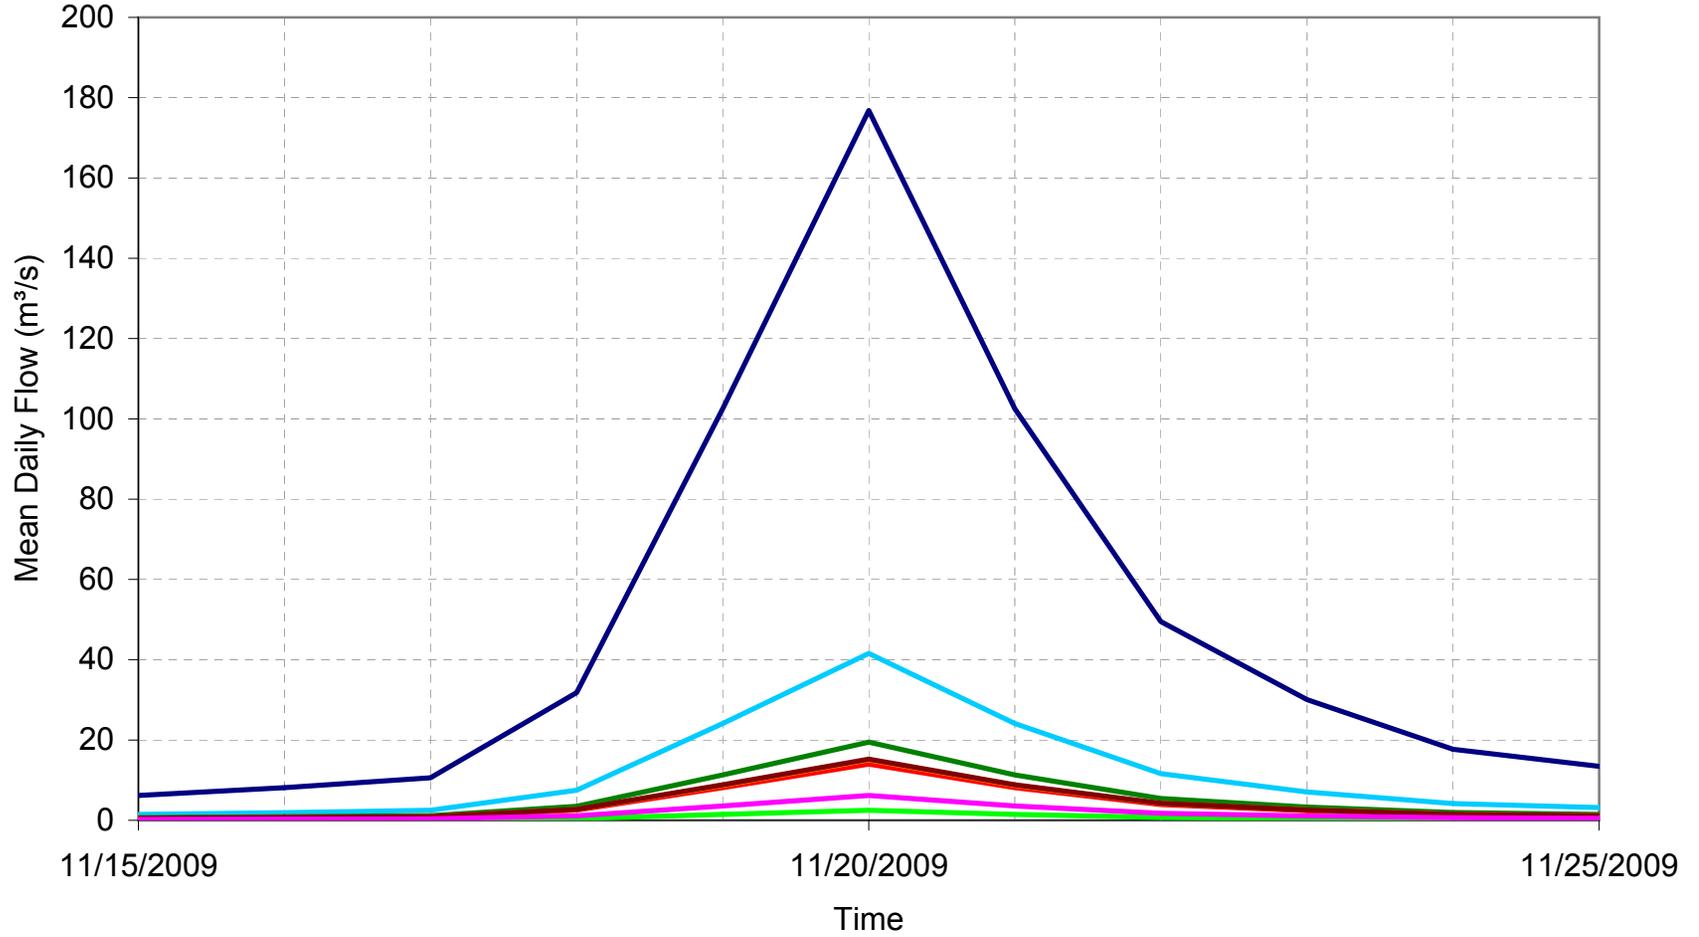
Figure 5.1

Discharges for the main tributaries (Kelvin Creek, Glenora Creek, Bing's Creek, Averyll Creek, Richards Creek, Quamichan Creek, unnamed tributary and Tzouhalem Creek) were included as point sources and are based on 25-year flows (Figure 5.1) obtained from the hydrology analysis for ungauged tributaries completed as part of the Cowichan Valley IFMP (Volume 2 – Technical Investigations). 25-year flows were used in the absence of better data; when the Bing's Creek gauge data becomes available, this assumption should be reviewed.

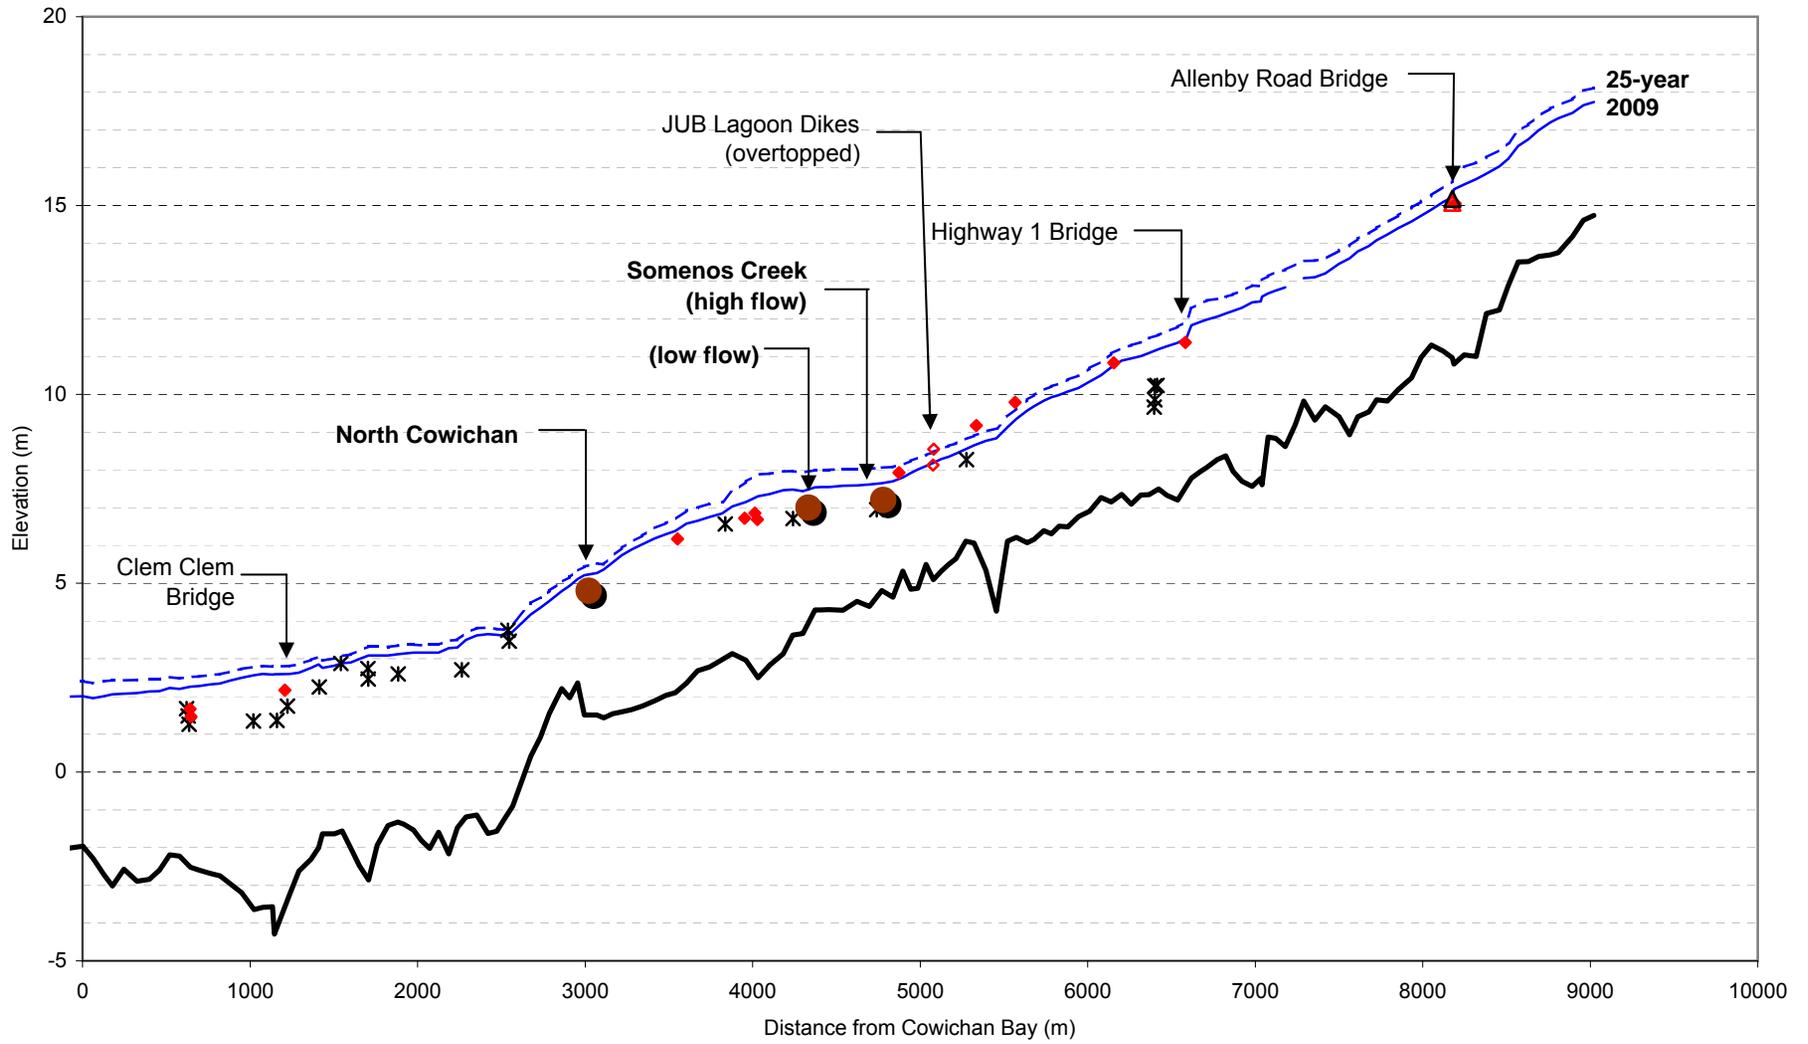
Figure 5.2

In general, the model results agreed well with surveyed and observed data. Longitudinal profiles comparing computed water levels and observed HWMs along the modelled reaches are plotted in Figures 5.2 to 5.5.

The modelled 2009 Cowichan and Somenos water surface profiles match or envelop the 2009 surveyed HWMs except along the portion of the Cowichan near the JUB lagoons (Figure 5.2) where modelled water levels are lower by more than 0.3 m and HWMs are closer to the modelled 25-year flood profile. The modelled Koksilah River water surface profile also exceeds the surveyed HWMs by more than 0.3 m. The comparison of surveyed and modelled levels is shown spatially in Figure
